# Used Equipment Machine Inspection

Inspection Number	15704385	Customer No	2969589938
Serial Number	2T300301	Customer Name	FINNING USED EQUIPMENT
Make	CATERPILLAR	Completed On	1/12/2024 12:51:38 PM
Model	725C2	Inspector	John Hardwick
Equipment Family	Articulated Truck	PDF Generated On	1/12/2024
Asset ID	HCE730695	SMU	4784 Hours
Location	Field Farm Northwich Road, WA4 4LJ, England, United Kingdom	Coordinates	0, 0, 0
Year	2017		
Inspector

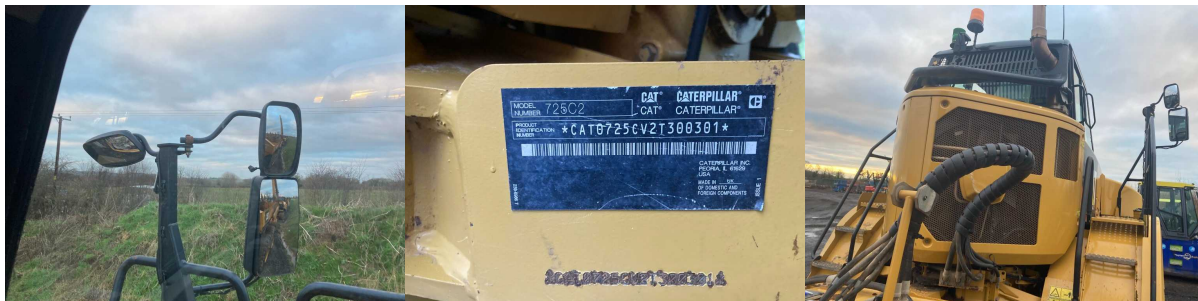
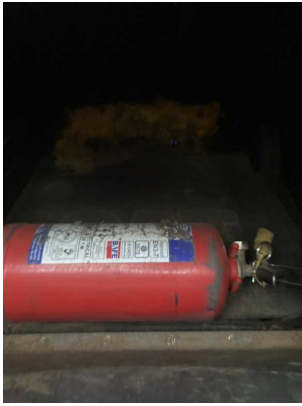
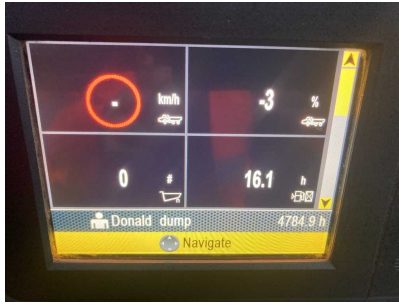
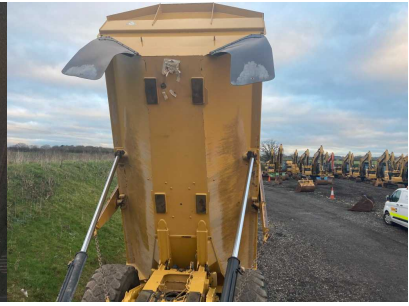
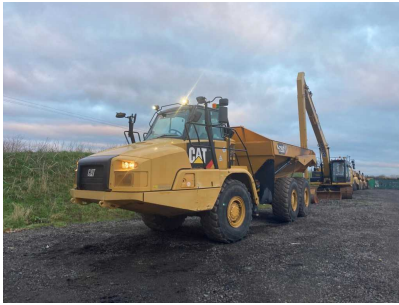
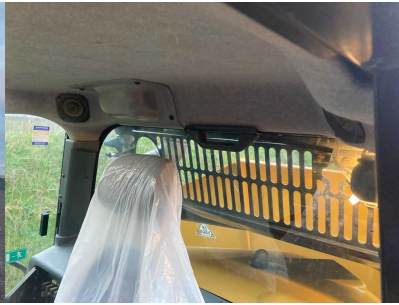
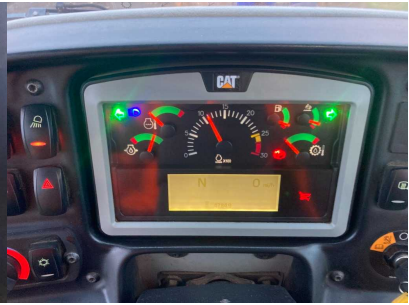
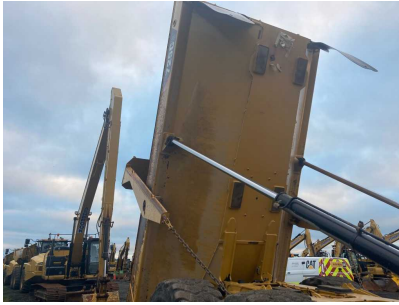
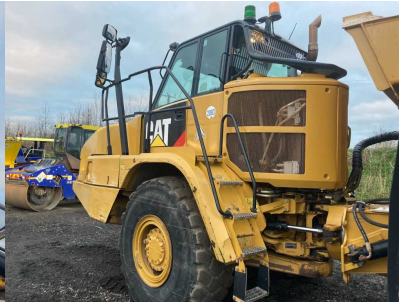
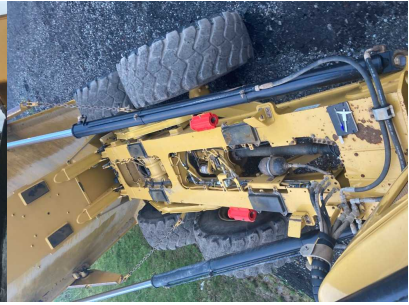
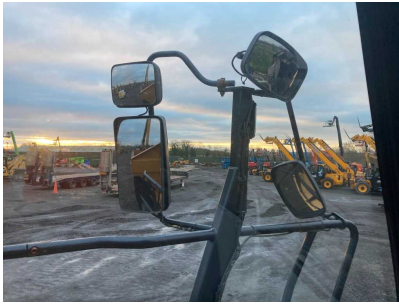
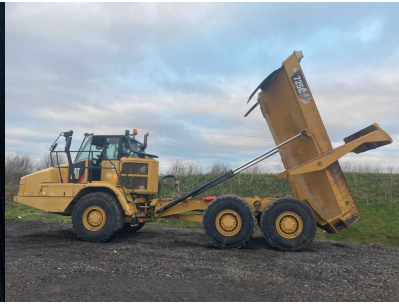
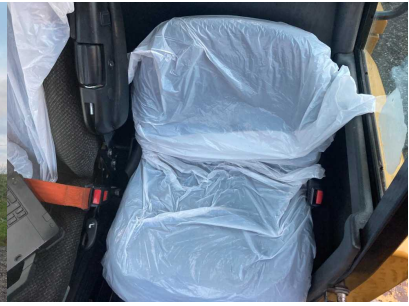
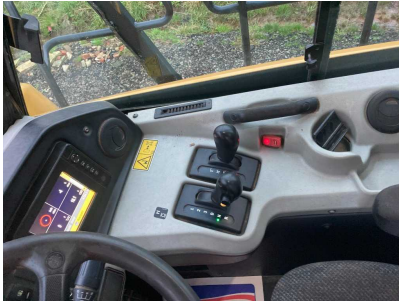
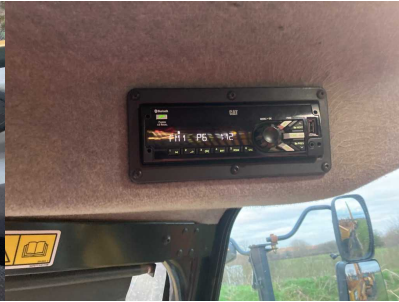
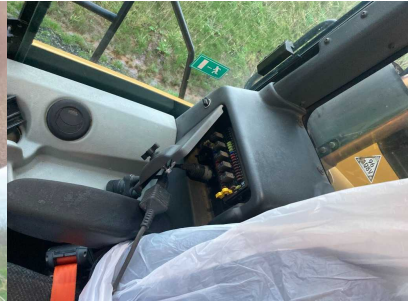
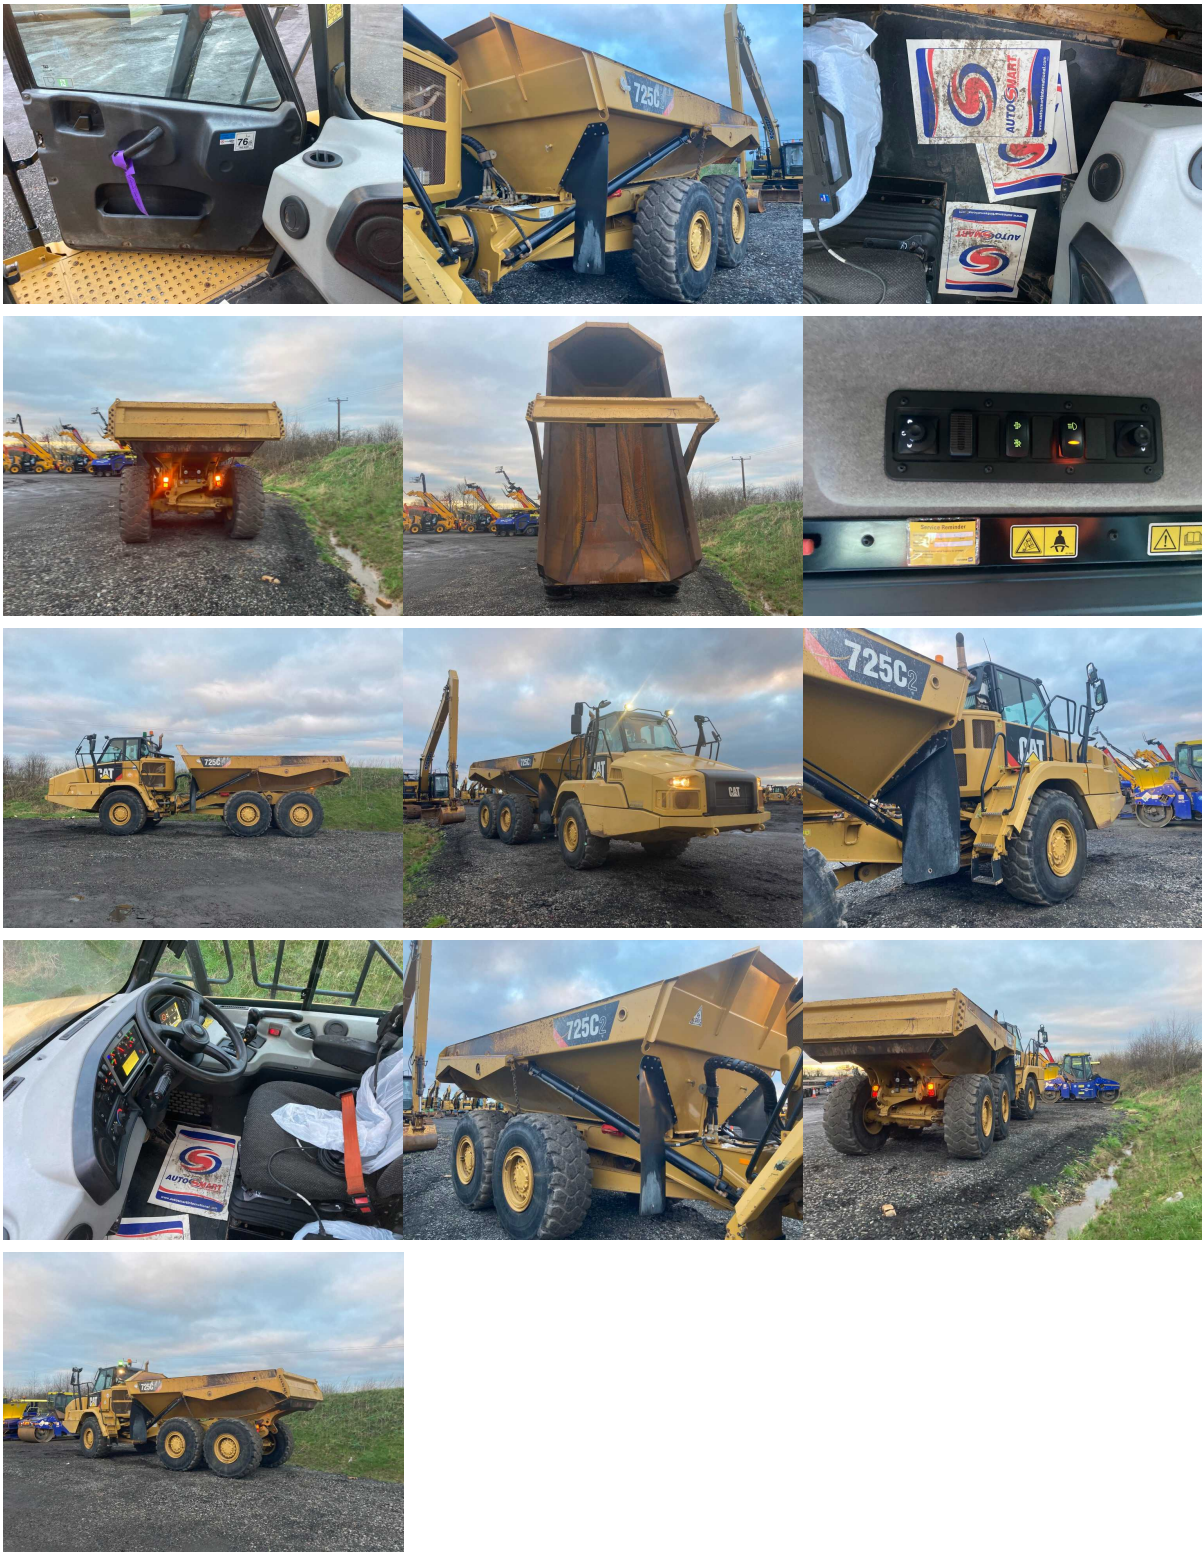
- **2.1 General condition** NO ACTION

Comments: Machine in overall good condition with no major general dents and scratches.

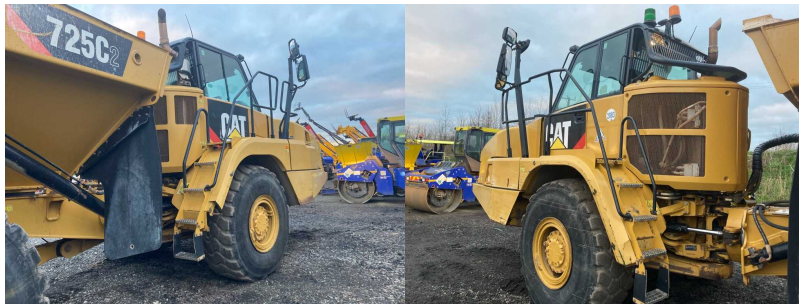
**2.3 Damage** *ATTENTION*

Comments: Front L/H and R/H mudflaps missing.

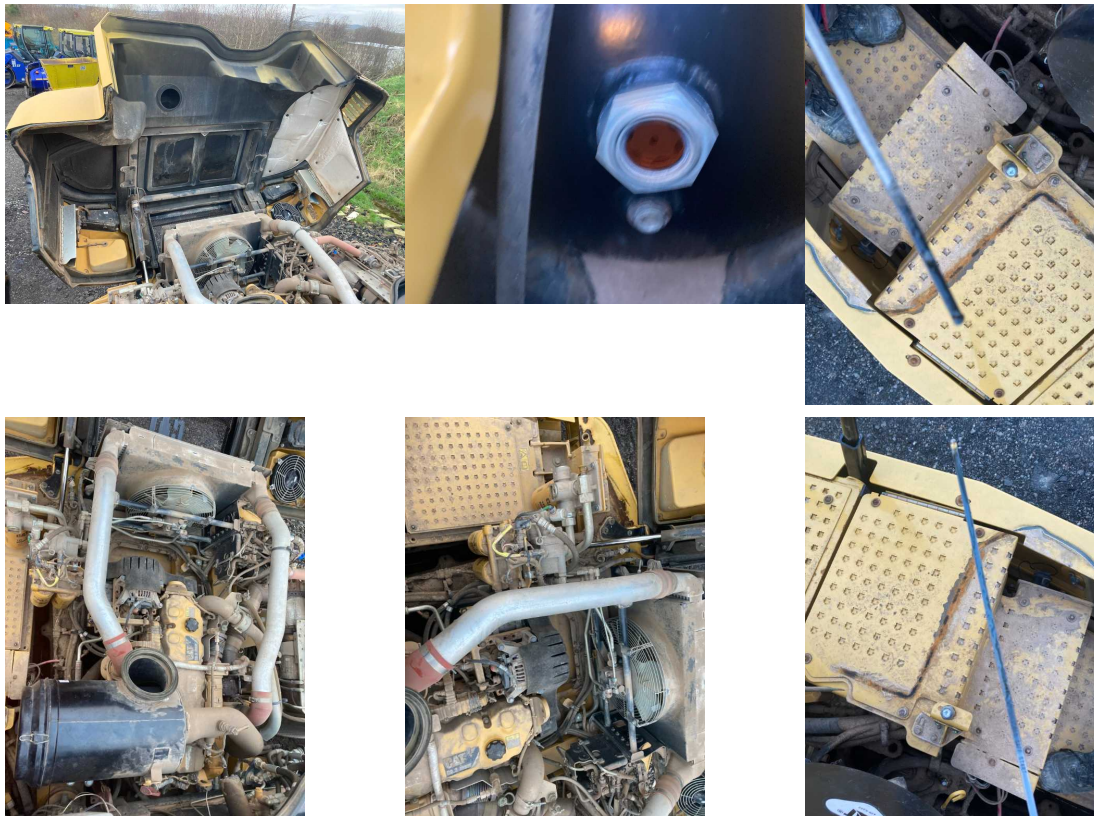
● **3.1 Engine**

Comments: Engine starts and runs with no issues seen or heard. Levels ok.

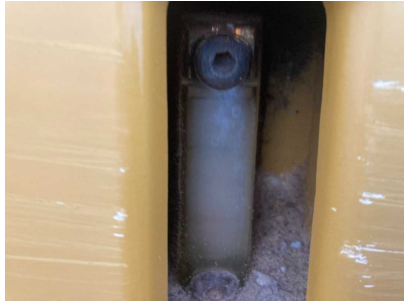
● **3.4 Hydraulics**

Comments: Hydraulics work as expected with no issues seen but level could do with topping up.

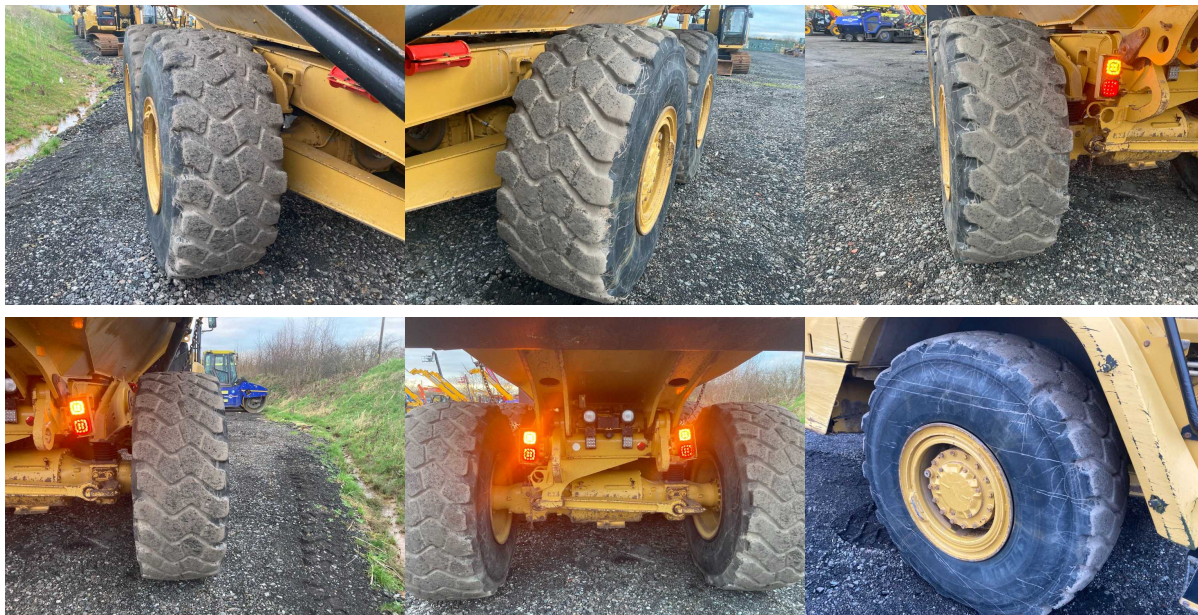
● **4.1 Tyres**

Comments: Tyres in a fair condition with some cracks and chunks out but not major. There is between 35% and 44% wear remaining on the tyres.

- F/L 44%.
- C/L 35%.
- R/L 35%.
- F/R 44%.
- C/R 38%.
- R/R 35%.
